GEOFABRICS CASE STUDY

GROYNE RECONSTRUCTION IN PORT OF DARLOWO, POLAND

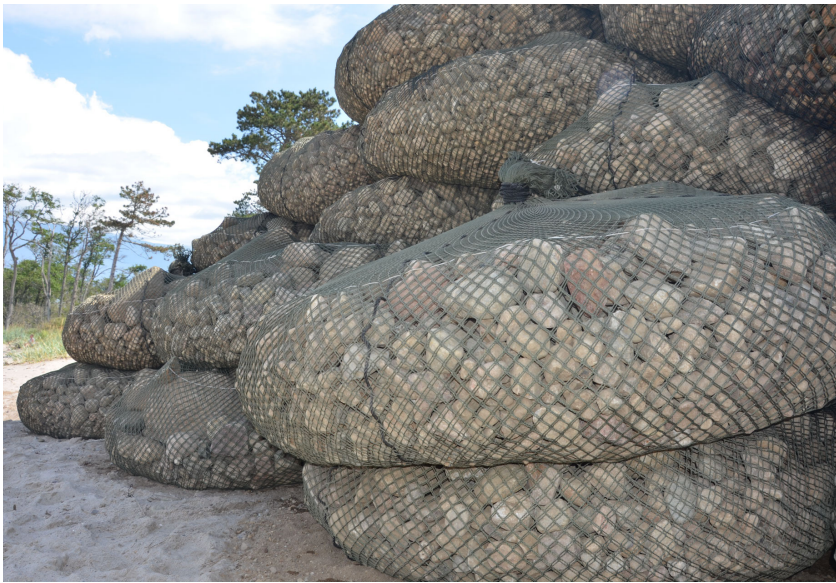
Following the groyne reconstruction, the bottom was strengthened using anti-erosion nets filled with stones (2T AquaRockBags) to enhance stability. By utilising AquaRockBags, the client saved on labour costs with its quick filling and installation process. The bags were filled in the warehouse yard and transported to the site, ready to be deployed.

53
groynes
reconstructed
